Manhole Inspection Summary

Manhole # S33AA_017MH

Insp Date: **3/20/08 9:42 AM**

Location Address: **713 HOWARD**

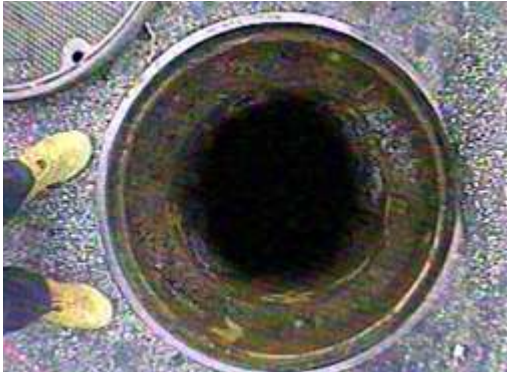
Top View

Offset: **2** (in.)

FRAME OFFSET

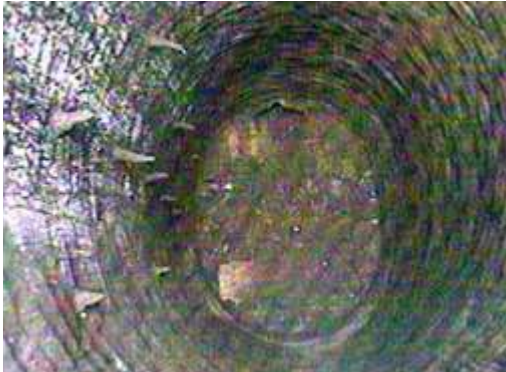
Defect 1

Count: **0** Missing: **8** ☐ Corroded

ALL STEPS MISSING

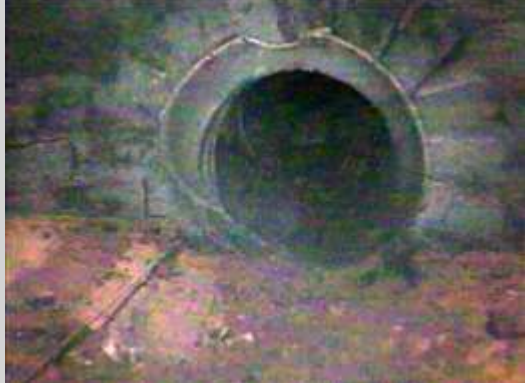
12 O'Clock Outflow

8 in. Circular Gravity Sewer
Pipe Out @ 12 O'Clock

Pipe Material: **Clay** ☐ Pipe Lined

Infiltration: **None** Pipe Seal Cond: **Sound**
